## Replacement derailleur cable

- 5 mm hex
- 3 mm hex
- pliers
- new derailleur cable  
1,1 mm thick,  
2200 mm long

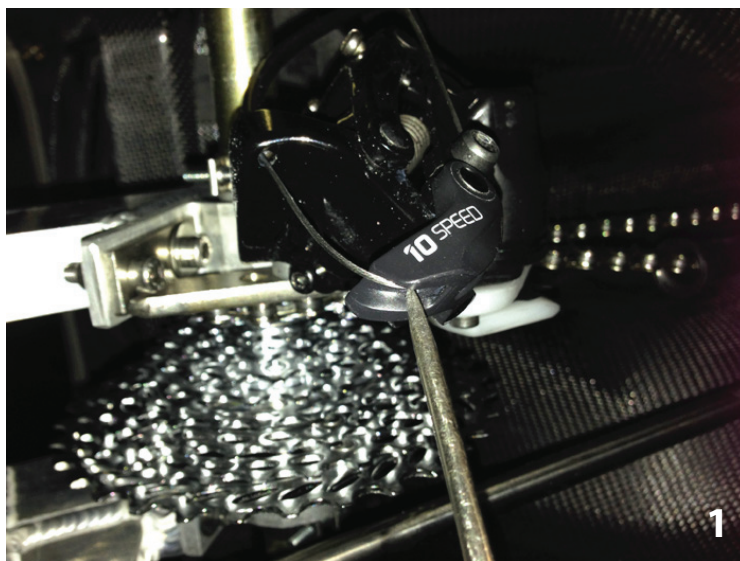
An early warning that the cable is about to break is unapprised index shifting. It usually breaks thread by thread and doesn't snap at once.

The cable usually breaks in the spot where it rolls on the cam. Pic 1.

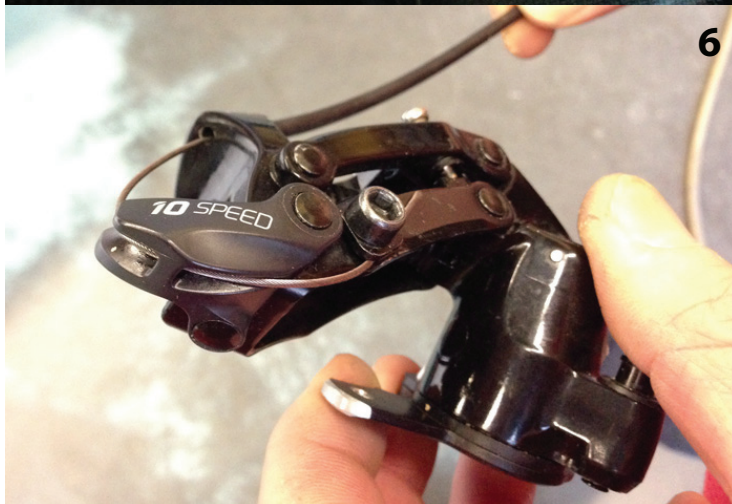
Be aware that the cable is routed under the bridge on the cam and clamped on the right side of the bolt under the plate. Pic 6.
